Manhole Inspection Summary

Manhole # S47K__037MH

Insp Date: **2/25/09 9:46 AM**

Location Address: **2051 fleet st**

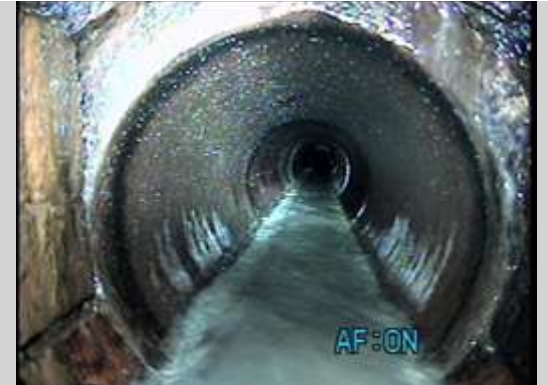
12 O'Clock Outflow

10 in. Circular Gravity Sewer
Pipe Out @ 12 O'Clock

Pipe Material: **Clay** ☐ Pipe Lined

Invert Depth: **13.30** (ft.) Flow Characteristics: **Fast**

Infiltration: **None** Pipe Seal Cond: **Unknown**

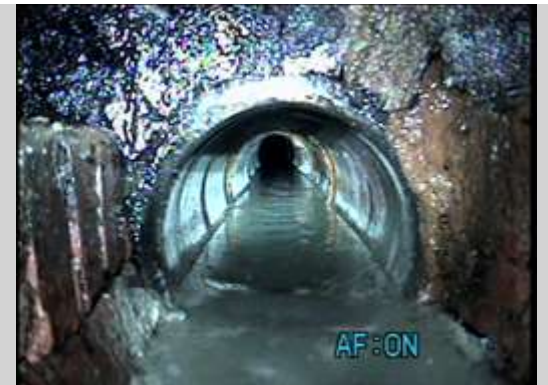
5 O'Clock Inflow

10 in. Circular Gravity Sewer
Pipe In @ 5 O'Clock

Pipe Material: **Clay** ☐ Pipe Lined

Infiltration: **None** Pipe Seal Cond: **Unknown**
